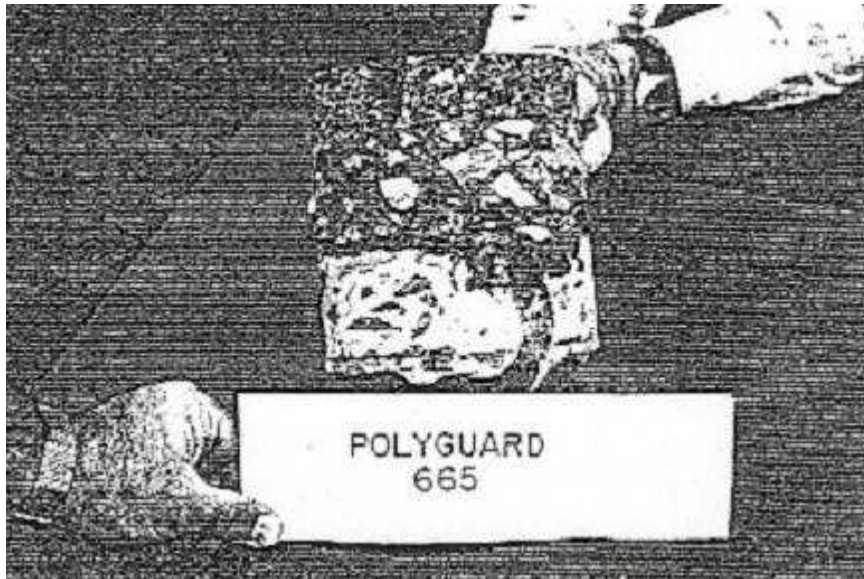
Figure 3

Section No. 1 - Polyguard 665, Station 675+75, 20 feet left of the curb. The reflection crack was offset from the underlying joint by two inches, (Figure 3) the membrane was intact over the joint and the debris that was carried into the reflection crack by the surface water has not intruded into the underlying joint. This membrane was intact and appears to be performing satisfactorily.
