# Two-Part Epoxy Deemed Best For Pipeline at Saltwater Channel

By **John Strong**, Technical Field Specialist, Pipeline Products Division, **Polyguard Products**

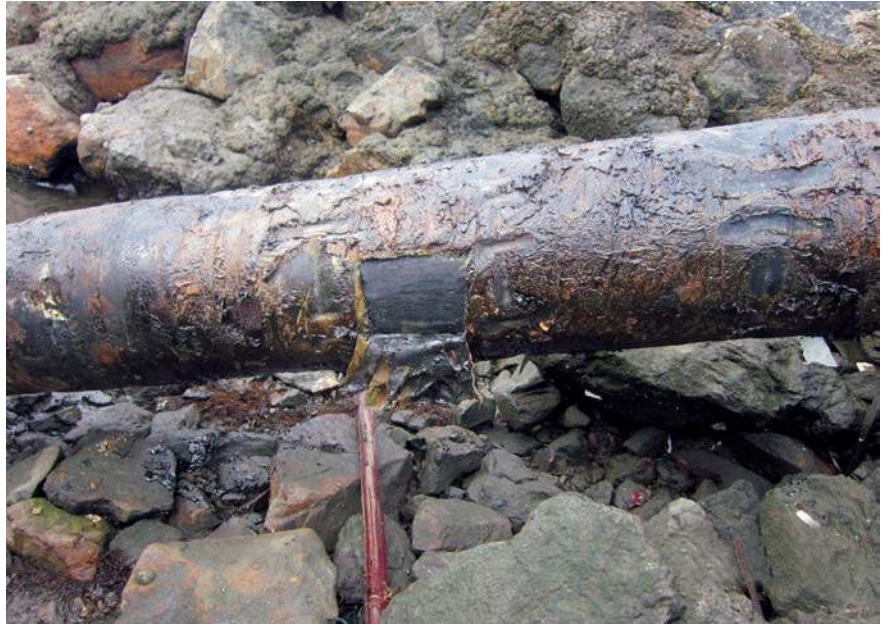
**Figure 1**

Time and the environment had caused the somastic coating to fail and crack along most of the tidal region of the pipeline. In the past, repairs on the coating had been conducted using soft petroleum-based wraps with an associated primer (**Figure 1**). The wraps were then encased in a thick high-density polyethylene (HDPE) shield to prevent floating debris from damaging the soft coating.

The thick plastic wrap also shielded the pipeline from cathodic protection current when the tide would rise to its installation level. While the cathodic protection would no longer protect the pipeline from corrosion, the soft petroleum-based wrap was also leeching into the channel during every tidal event.

These petroleum-based wraps need to be sealed to prevent leeching into the soil or water. The seal most likely would also have shielded cathodic protection current but it would have kept the primer from leeching into the channel. Eventually, after enough tidal events, the petroleum-based wrap would act as a sponge for the saltwater.

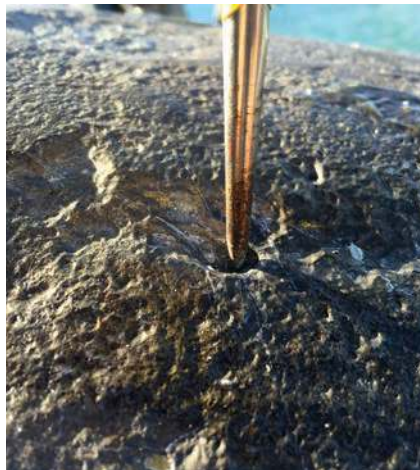
**Figure 2**

As the tide rose, it would get wet. As it fell, it would hold the saltwater against the pipe surface where no cathodic protection could protect it due to the pipe being above the surface (**Figure 2**).

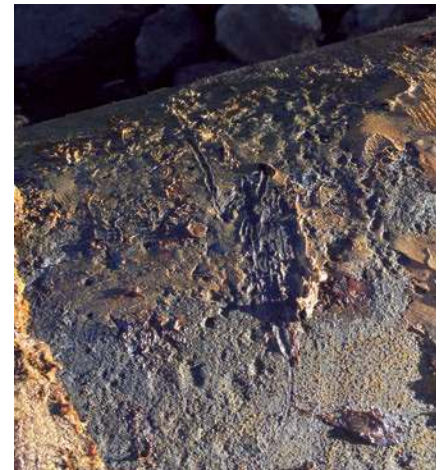
**Figure 3**

The initial integrity assessment by the operator required sleeving the pipelines for the entirety of the tidal range. Anomalies were found that required immediate repairs, and most of the extensive damage was

under the coating that received the wet-dry cycling (**Figure 3**).
