# Is Your Pipeline Coating ‘Fail Safe’?

By **Richard Norsworthy, Polyguard Products, Inc.**

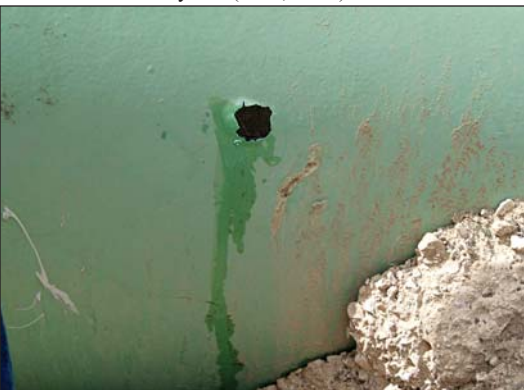
“Fail Safe” FBE coating in central U.S. with blisters. Water pH was 12 with no corrosion under FBE.

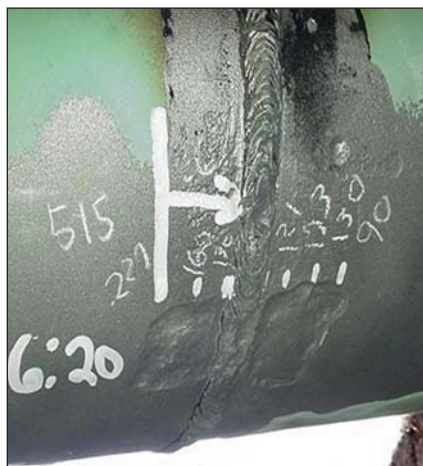
Soil stress caused wrinkles in shrink sleeve on 10-inch pipe which allowed water and SS shielded CP, resulting in significant corrosion after eight years.

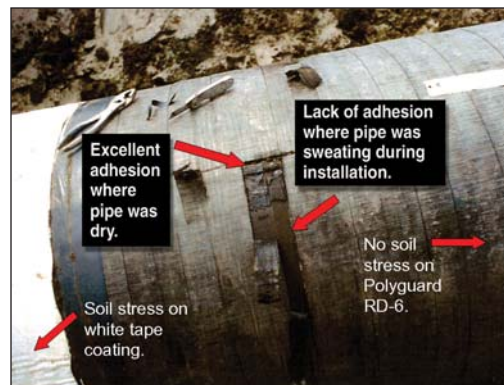
RD-6 applied for three years on partially sweating pipe in severe soil stress area. No bond to area where pipe was sweating at installation, but pH was 11 on water under the coating proving “Fail Safe”. Notice wrinkles on white tape, but no wrinkles on RD-6.

13. The two occasions water has been found under this coating (once was an application problem and the other was the intentional application to a wet pipe) the pH was 10 to 11, indicating adequate CP for protection is being achieved under the disbonded area.

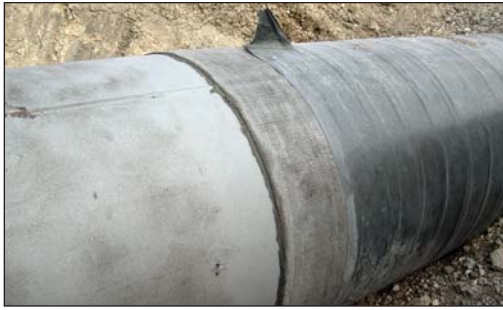
RD-6 coating system condition shown is after one year in severe soil stress area. Use of "Slip Plane" non-shielding, non-bonded outer wrap enhances soil stress resistance.

is resistant to soil stress effects, especially when the complete system includes the use of unbonded (slip plane type) outer wrap.
