Field Testing of New Novel Technique for Controlling Crevice Corrosion on Rocker Assemblies

WAYNE SOUCIE and NANCY HEIMANN, Elisha Technologies Co. LLC, Moberly, Missouri

IBC-04-13

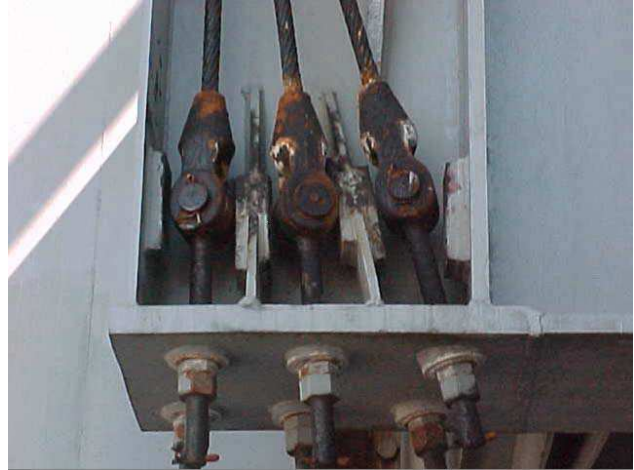
Figure 2 – Typical Corrosion on US Navy Deck Edge Elevator Cables

Adaptations of surface Mineralization technology have also been incorporated in to wire rope corrosion remediation. This particular system has been installed on approximately 40% of NS Navy aircraft carrier deck edge elevators (Figure 2 & 3).

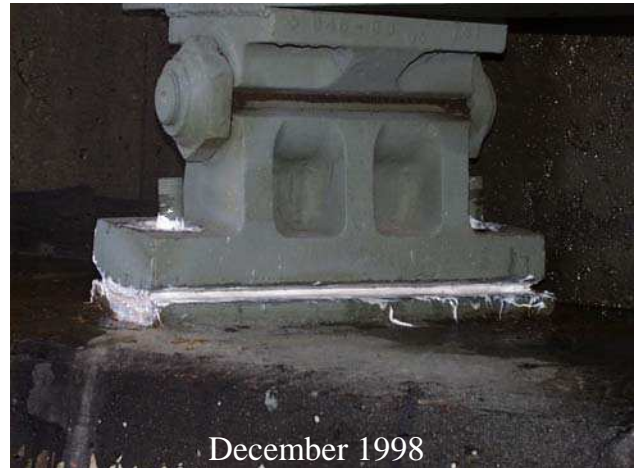
Figure 5 – Rocker Assembly After Gel Application - December 1998

APPLICATION - On December 29, 1998, alternating rocker assemblies were cleaned to remove debris and Elisha E-2400 gel was applied on the bearing plate and the rocker contact surface. In addition the locator bolts holes were filled with E-2400 to minimize the potential for water infiltration via this pathway. On one rocker assembly the exposed area of the wrist pin joint was also coated with E-2400 to determine the effect this product on inhibiting corrosion in this area.

The rocker assemblies were inspected periodically to collect data with regard to the progression of corrosion on the standard rocker assemblies and the units that were protected using E-2400 gel. Photographs of the progression of corrosion are shown in Figures 4 – 8.

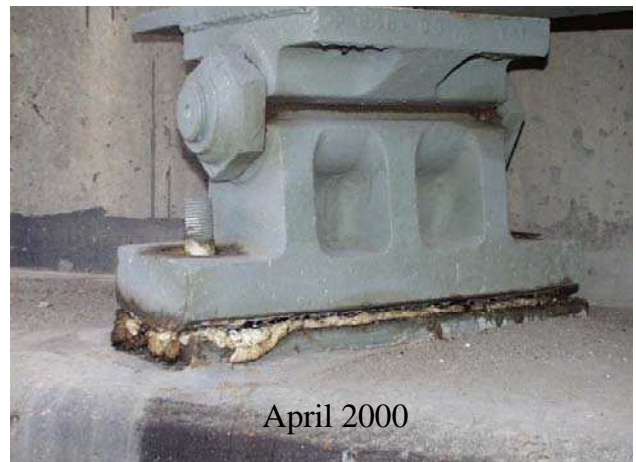
Figure 6 – Rocker Assembly Inspection – April 2000

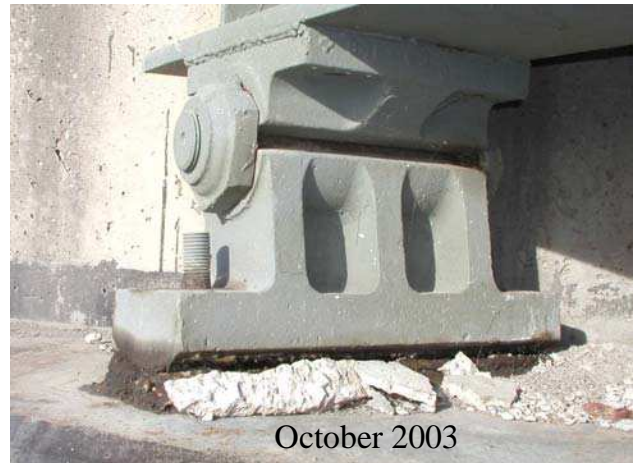
Figure 7 – Rocker Assembly Inspection – October 2003

SUMMARY RESULTS/ OBSERVATIONS - After five years exposure, the rockers not protected by the E-2400 gel continued to exhibit corrosion activity. The assemblies protected by the gel have not exhibited recurrence of corrosion in the areas where the gel was applied. The gel appears to resist washout and displacement by movement as evidenced by minimal displacement of material from the original installation. Some leaching of protective material is occurring, as evidenced by progression of oil to a distance of 0.75" from the mass of the product. The gel material remains tacky and compliant on the surfaces of the rocker. By remaining pliable, the gel is able to maintain contact with the surfaces to be protected. Dust dirt and debris have collected along the edges of the application but this collection has not impaired the functionality of the gel as a corrosion inhibitor. E-2400 is recommended for incorporation into bridge design, construction, and maintenance engineering specifications.

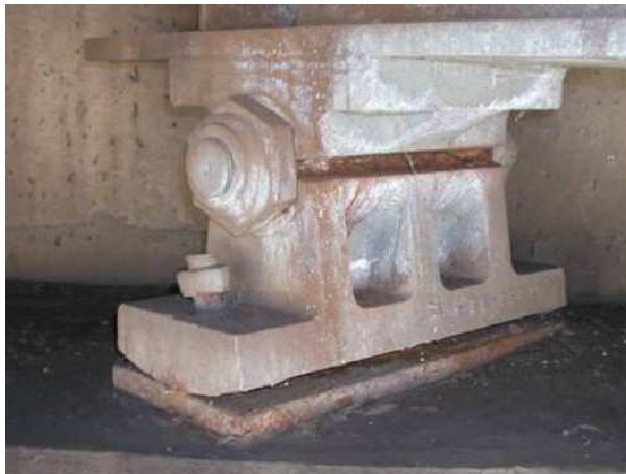
**Figure 8 – Uncoated Rocker Assembly
Inspection – October 2003**

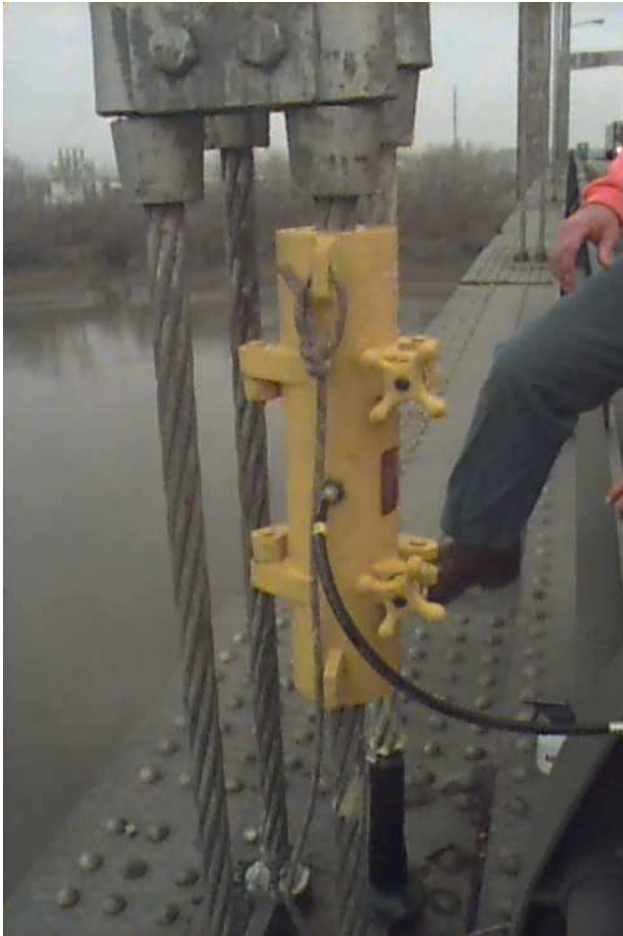
**Figure 9 – Bridge Stay
Pressure Lubrication – March 2004**

APPLICATION - Stay connecting points were cleaned with wire brush to remove debris. Elisha E-1270 wire rope lubricant was injected into the wire rope stay with a pressure injector for a distance of approximately four feet above the traffic deck (Figure 9). Stretch film was spiral wrapped around the application. A two-step mechanical protective sleeve of DPS 601 mastic material was applied. The base was covered with two pieces of mastic material extending approximately two inches up the wire rope. A large piece was cigarette wrapped around the bottom 12" of the application with a one-inch overlap. A stainless steel band clamp was used at the top of the application to compression the top entry (Figure 10).

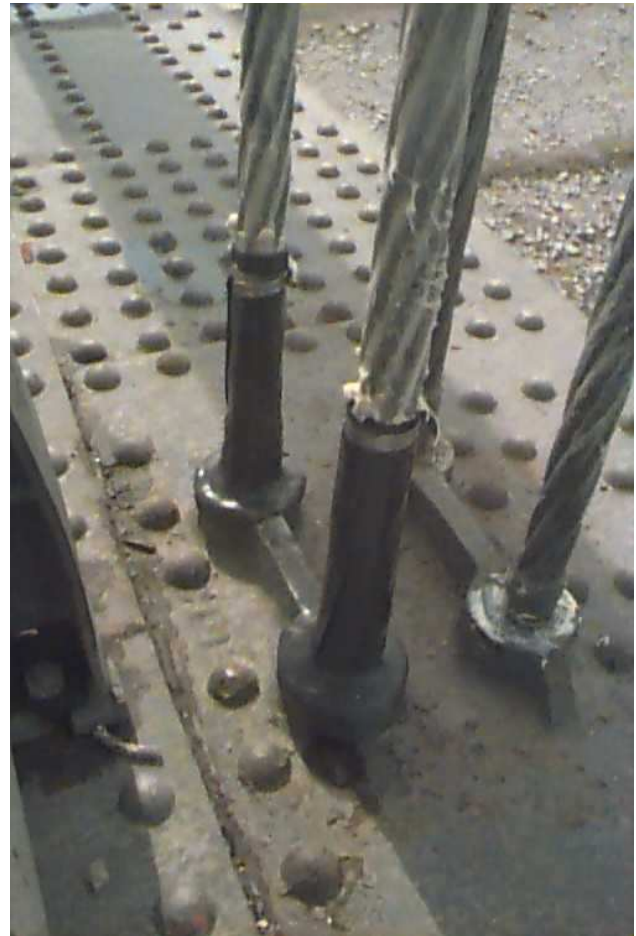
**Figure 10 – Bridge Stay
Finished Application – March 2004**
